## Robbins Bros. Circus Side Show Canvas Wagon No. 86

# Circus Model Builders

Drawn By  
Karl H. Hartisch

DRAWING NUMBER  
**#0183**

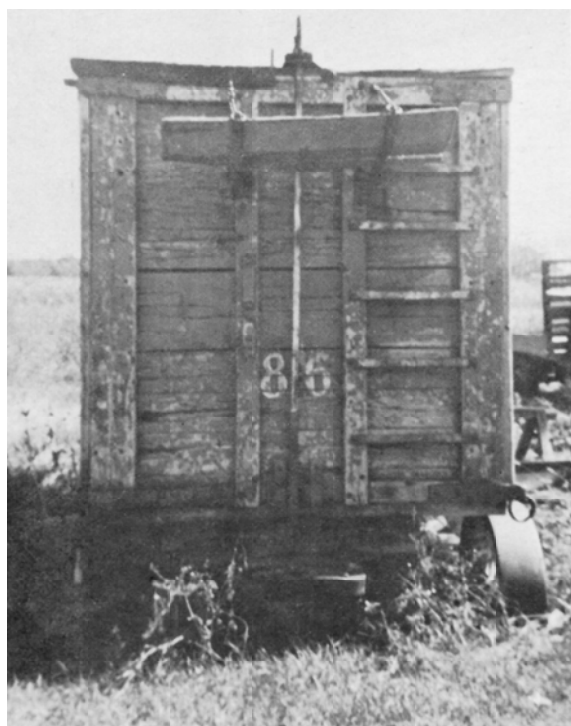
Front view of "Old No. 86" side show canvas wagon.
